# **Thermal Control Materials on MISSE-6 With Comparison to Earlier Flight Data**

Miria M. Finckenor  
NASA/Marshall Space Flight Center

National Space and Missile Materials Symposium  
Scottsdale, AZ  
June 2010

## Materials on International Space Station Experiment (MISSE) - 6

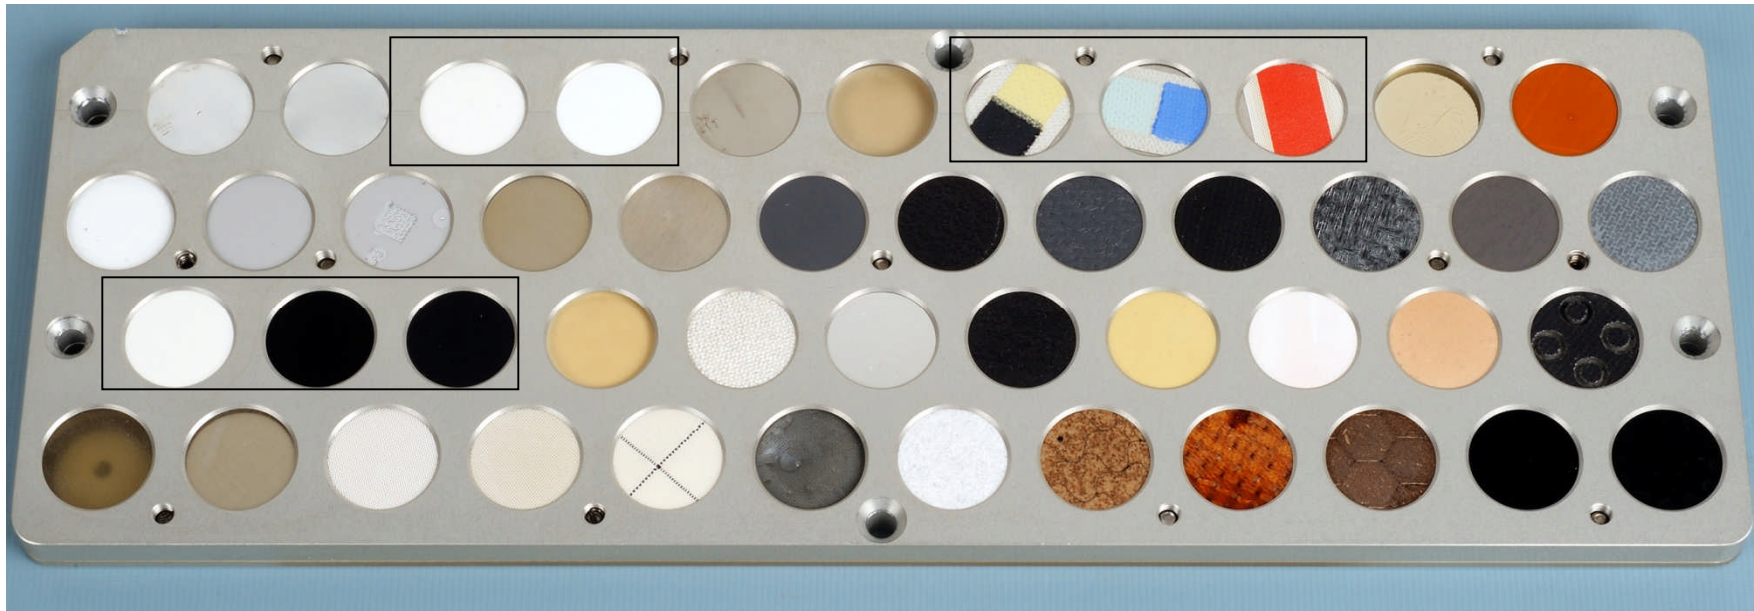
Ram-facing -  
AZ93 w/Teflon, AZ93,  
TMS800IY/TMJ-20LSB, AMJ760/AMJ750, AMJ600IR  
AZ400, MLS85LSB conductive, MLS85LSB

- $\sim 2 \times 10^{21}$  atoms/cm<sup>2</sup> atomic oxygen (Kapton erosion)
- $\sim 2,600$  equivalent sun-hours UV

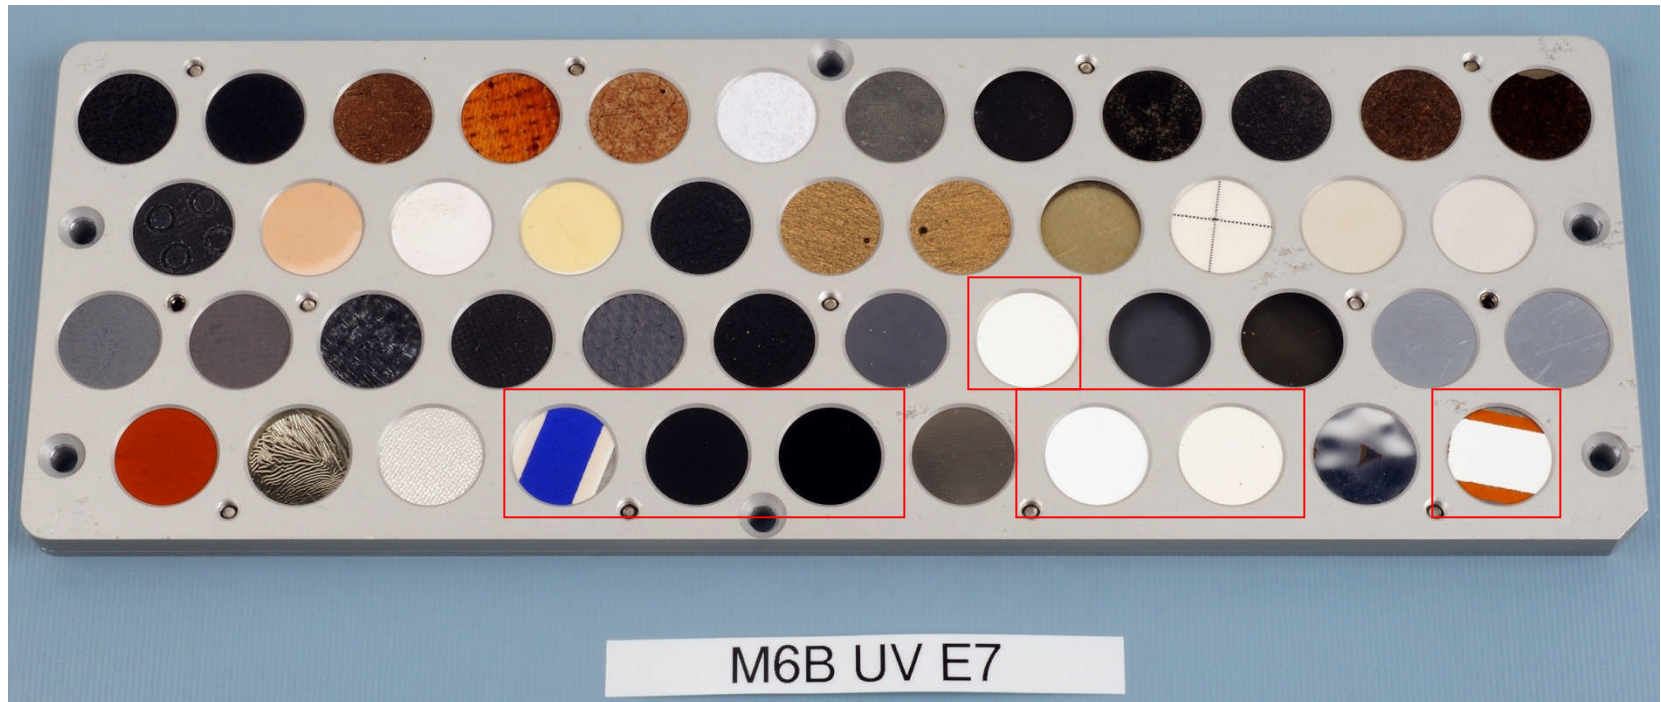
Wake-facing –  
AZ400,  
AMJ-700-IBU, MLS85LSB, MLS85LSB conductive,  
AZ93, AZ93 w/Teflon, AZ93 on Kapton

- $\sim 1.4 \times 10^{20}$  atoms/cm<sup>2</sup> atomic oxygen (Kapton erosion)
  - $\sim 1,950$  equivalent sun-hours UV
- >8,400 thermal cycles of +40/-40 °C

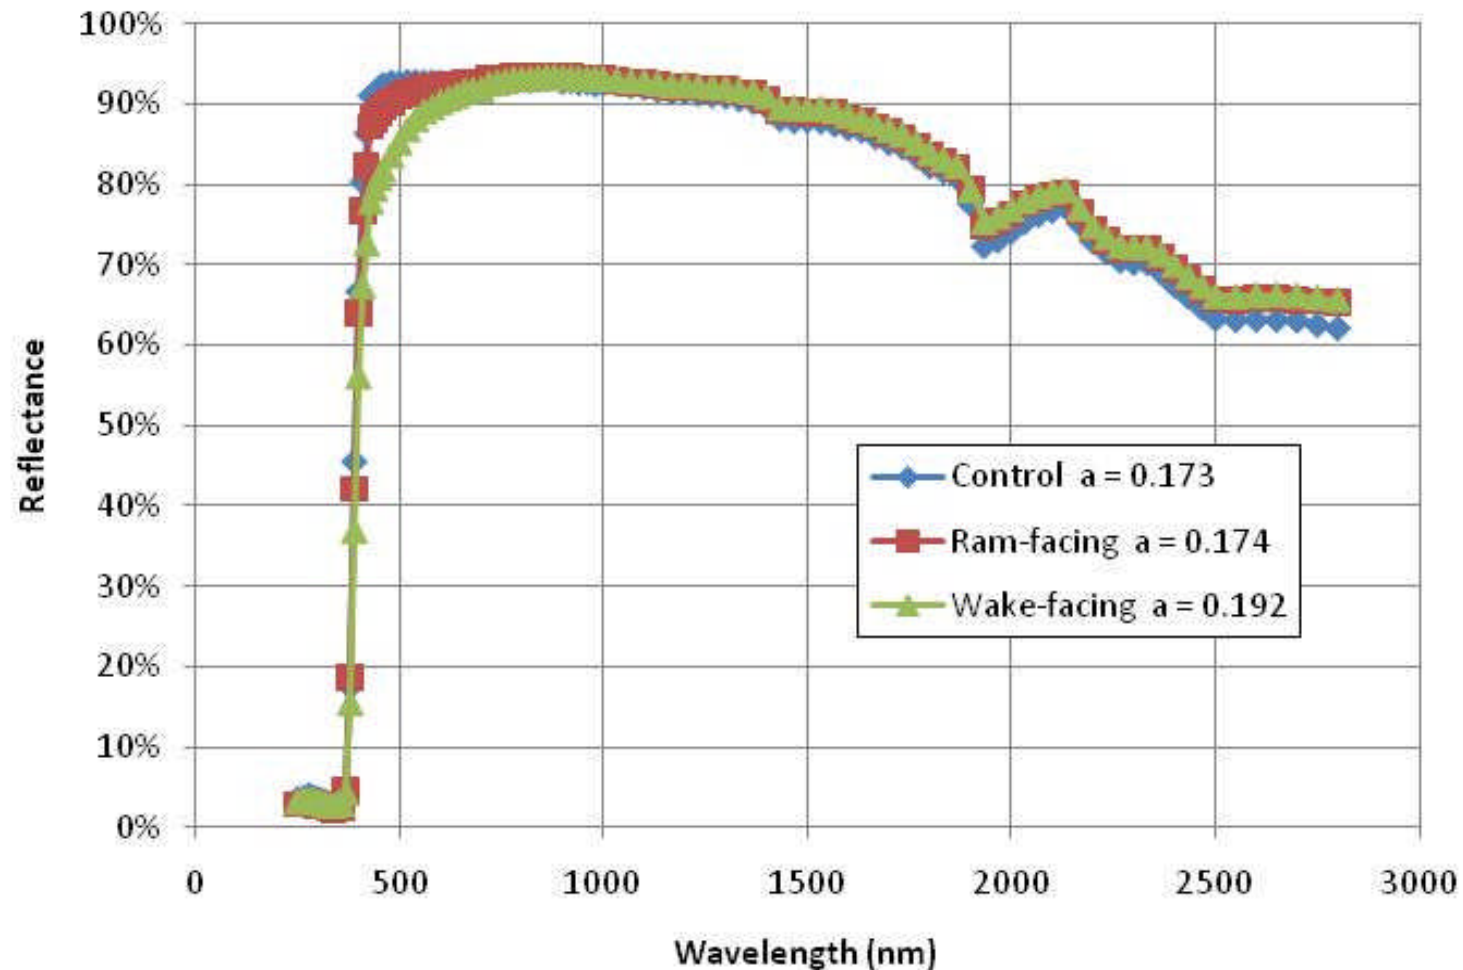
### MISSE-6 AZ93 with Teflon overcoat

Samples from MISSE-3 and -4 also ranged from 0.17 to 0.19 in solar absorptance

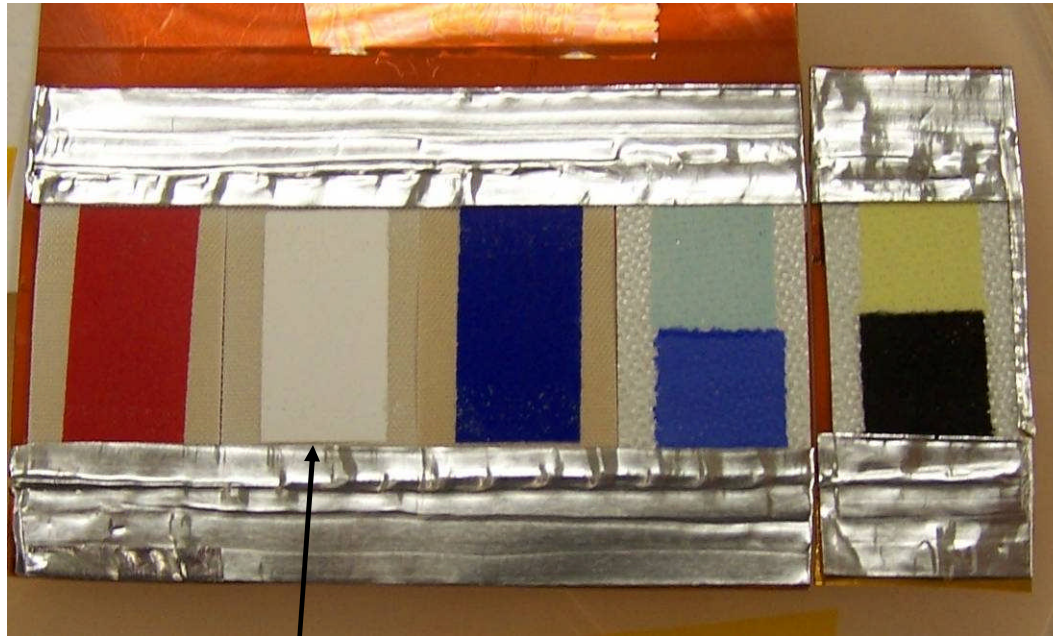
Previously flown AZ93 on Beta Cloth on MISSE-5.  
Change in reflectance spectra may indicate darkening of  
beta cloth underneath coating.  
MISSE-6 AZ93 applied slightly thicker.

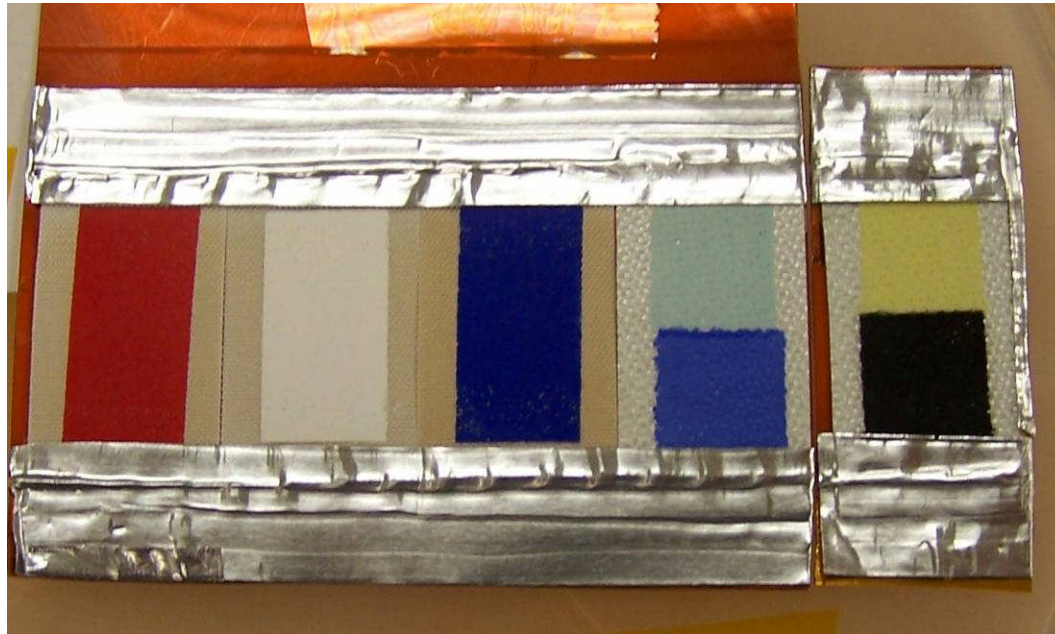
Left to right, AMJ600IR, AZ93, AMJ700IBU on beta cloth,  
AMJ760/AMJ750 , TMS800IY/TMJ-20LSB screen printed  
on Dutch glass cloth

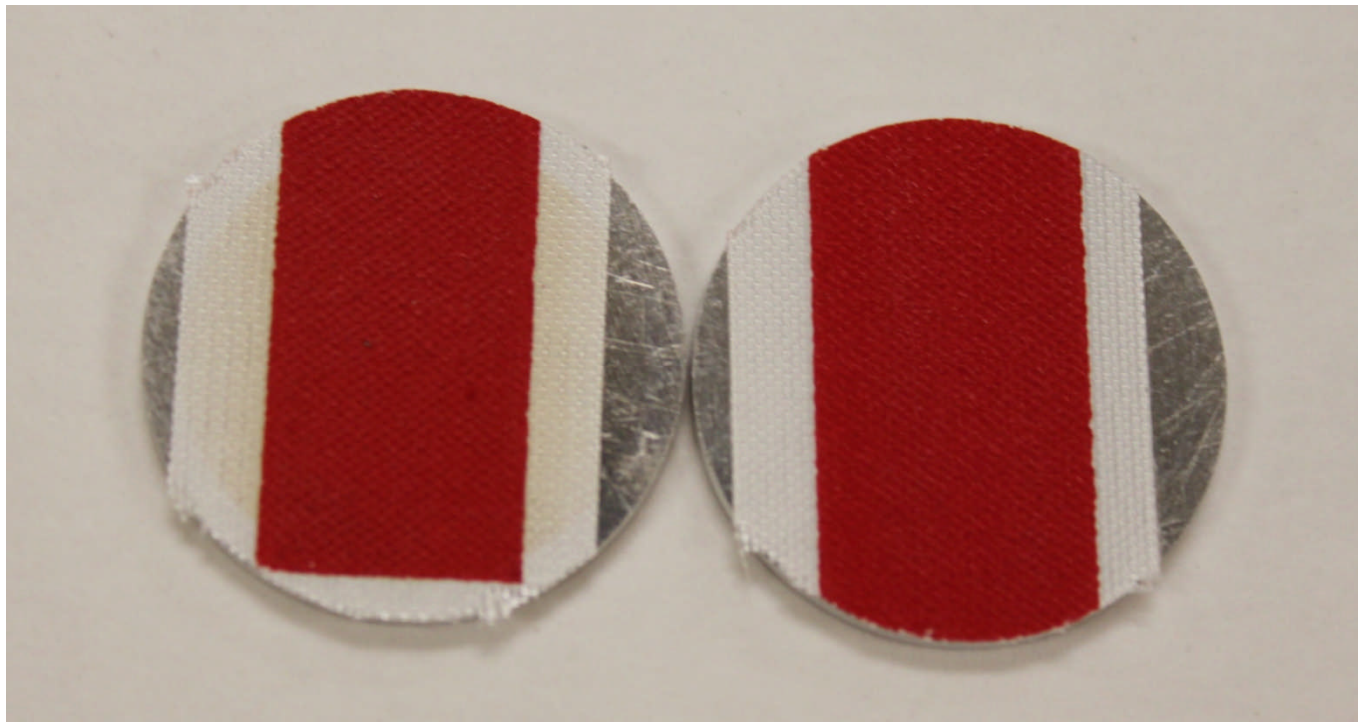
## Marker Coatings - AMJ600IR

Flight Ram-facing

Control

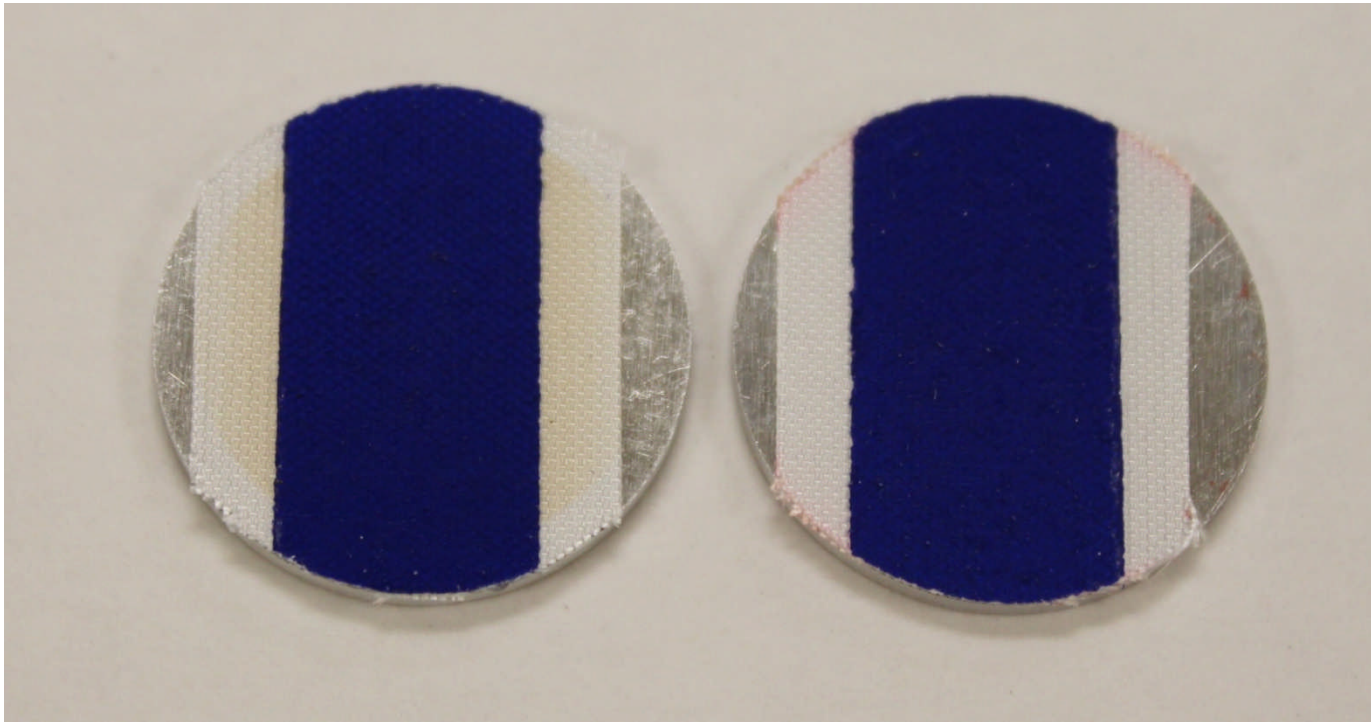
## Marker Coatings - AMJ700IBU

Flight Wake-facing

Control

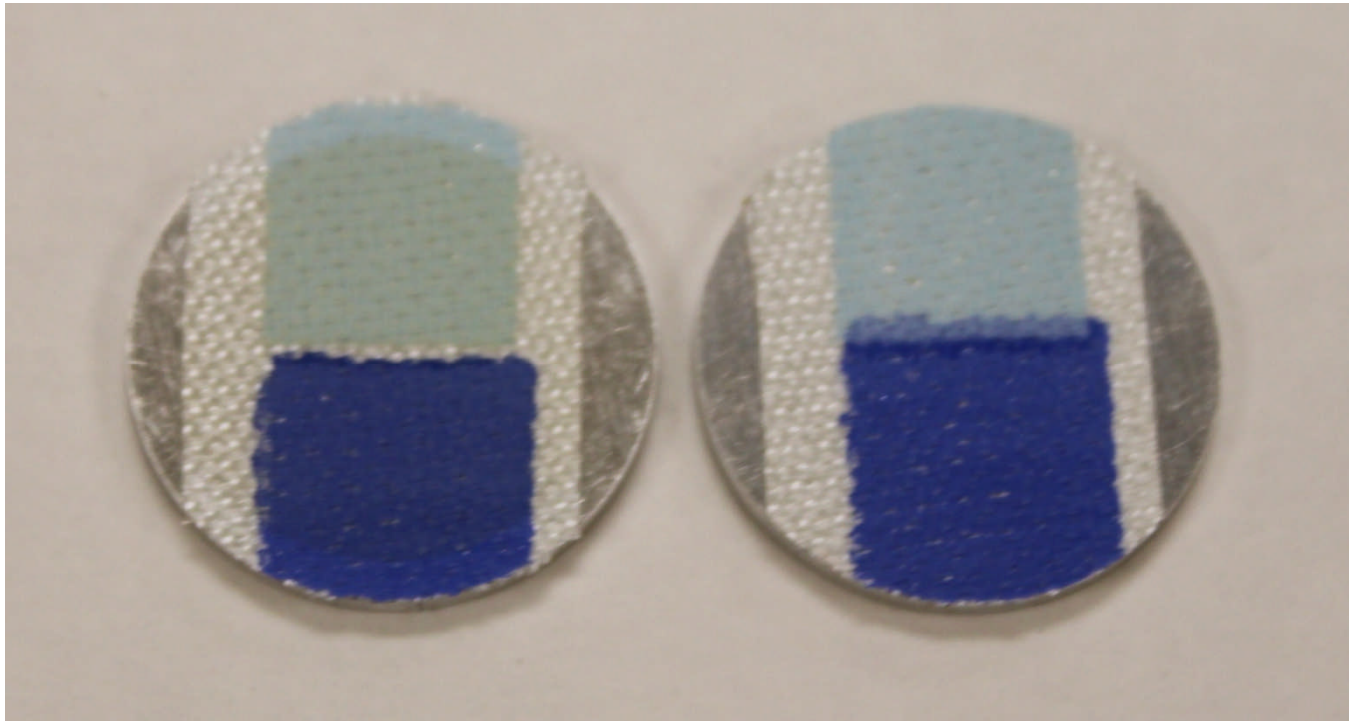
## Marker Coatings - AMJ760/AMJ750

Flight Ram-facing

Control

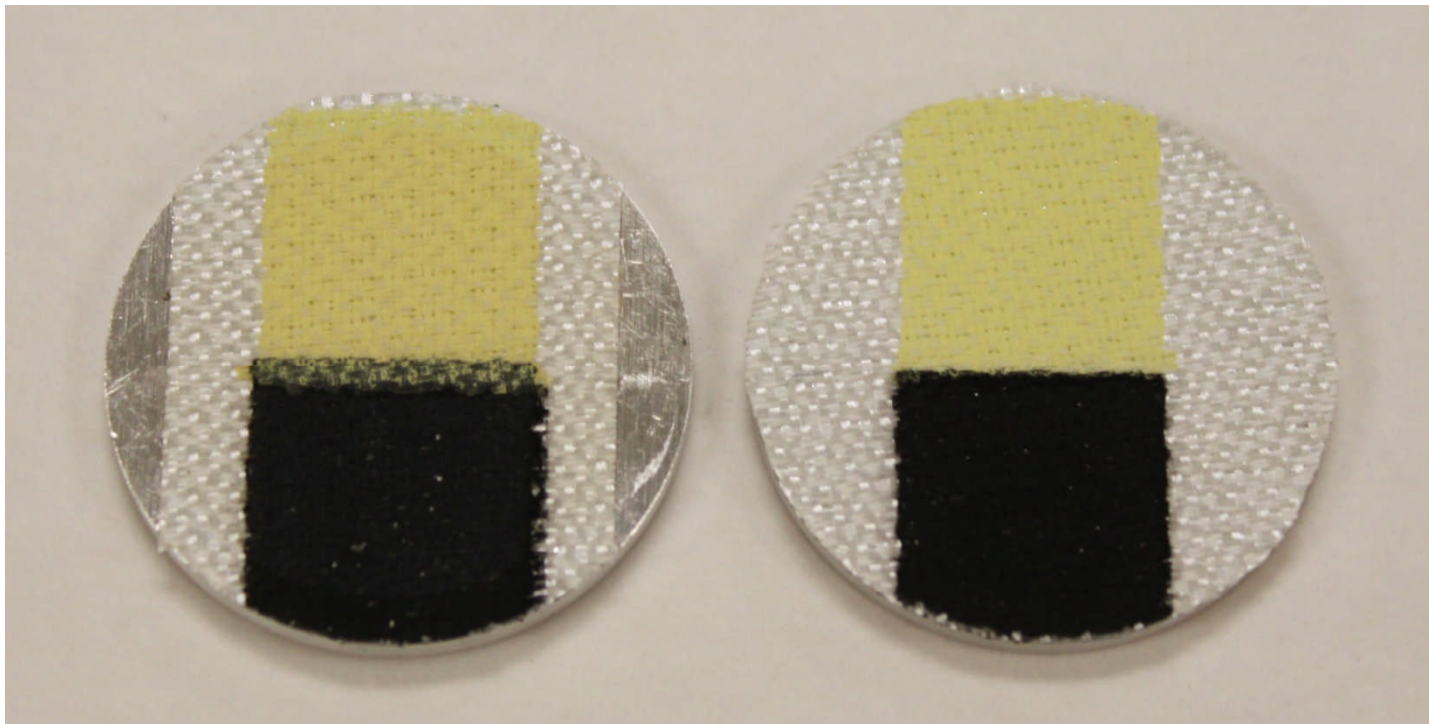
## Marker Coatings - TMS800IY/TMJ-20LSB

Flight Ram-facing

Control
